Failure analysis and degradation mechanisms of GX130CrSi29 grate bars in a biomass-fired furnace: An industrial case study

Premature degradation of grate bars is a persistent operational challenge in biomass-fired furnaces, particularly when alkali-rich fuels are used, leading to increased maintenance and unplanned outages. Although biomass combustion and ash chemistry have been widely investigated, detailed failure analyses based on service-exposed grate components from operating power plants remain relatively limited. This study investigates the degradation behavior of GX130CrSi29 grate bars retrieved from a 9.9 MW rubberwood-fired reciprocating grate furnace. Failed components

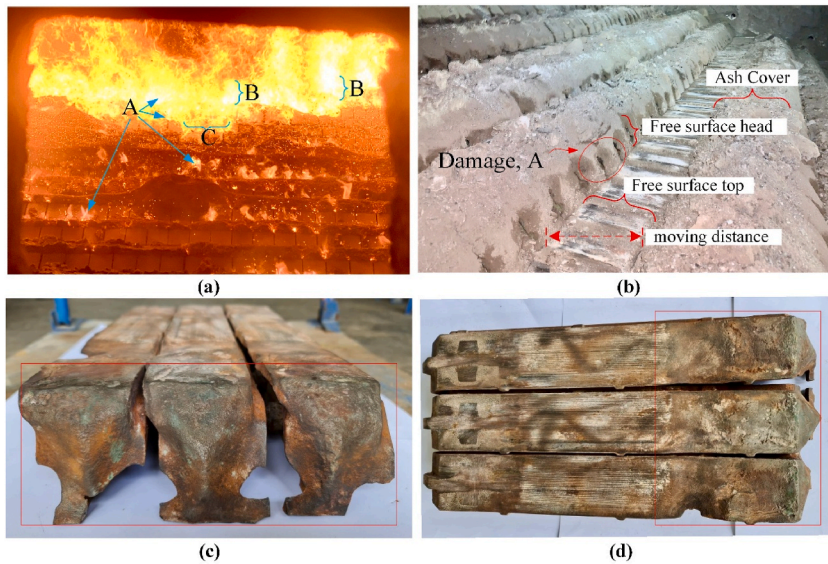
Fig. 3. (a) Over-grate view of the combustion zone showing flame-front position, ash coverage, and exposed grate surfaces used to identify sampling locations. (b) Field removal of failed grate bars showing free-surface regions, ash-covered zones, and localized damage at the leading edge. (c-d) Extracted grate specimens after cooling, highlighting severe material loss at the head region and progressive degradation along the grate motion direction.

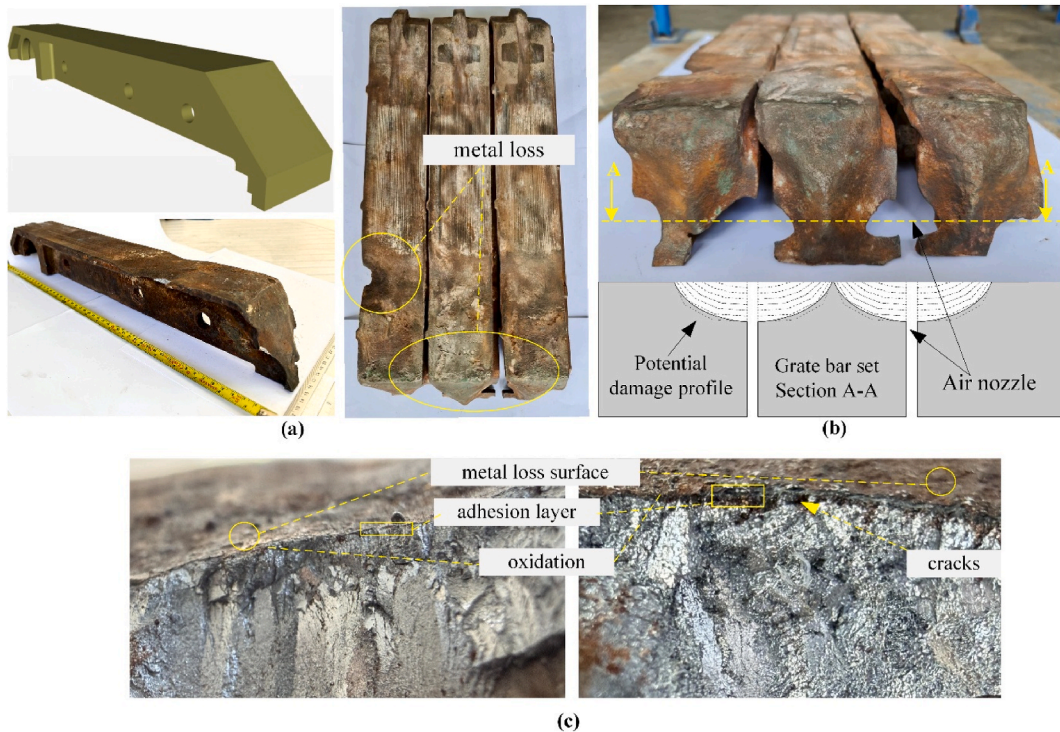
Fig. 5. Macroscopic morphology of failed grate bars: (a) Overall geometry of extracted bars with reference CAD profile for comparison. (b) Severe leading-edge degradation characterized by metal loss, deformation, and localized melting. (c) Surface oxidation, slag adhesion, and crack formation observed along the upper surface of the grate bar.

Sample A, retrieved from the leading-edge region, shows the most severe damage, characterized by extensive metal loss, localized surface melting, and thick slag adhesion. Sample B, originating from the mid-grate region, exhibits comparatively moderate degradation with thinner slag accumulation and shallower section loss. Sample C, also taken from the leading-edge region but prepared using controlled cutting, displays damage characteristics similar to Sample A, indicating that the most aggressive degradation occurs consistently at the flame-facing front regions of the grate.

Despite differences in severity, all specimens share several common macroscopic features, including pronounced surface roughening, oxide scaling, resolidified slag adhesion, crack networks associated with thermal cycling, and non-uniform thinning of flame-facing surfaces. These recurring damage patterns suggest that grate degradation is primarily associated with the thermochemical exposure environment of the furnace rather than with localized material defects or compositional non-conformance.

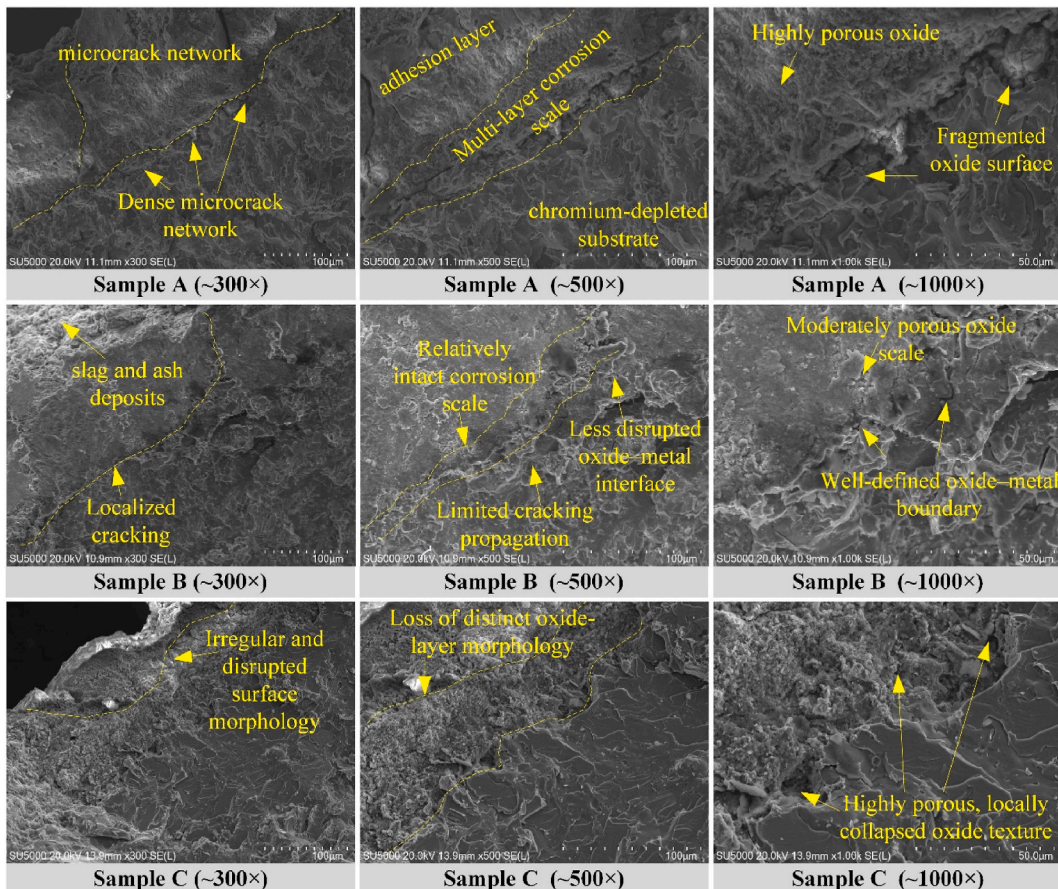
Low- and high-magnification cross-sectional SEM images of Samples A–C reveal a reproducible multilayer corrosion architecture across all investigated grate bars, with position-dependent variations in layer thickness and morphology (Fig. 6). The structural sequence of the corrosion layers and the compositional contrast between them are further illustrated in the corresponding cross-

Fig. 6. Representative cross-sectional FE-SEM images showing position-dependent corrosion morphology of GX130CrSi29 grate bars. Sample A (leading-edge region) exhibits a thick multilayer corrosion scale, a degraded Cr-enriched inner oxide, and a Cr-depleted substrate with highly porous Fe-rich outer oxide. Sample B (mid-grate region) shows thinner deposits and a more continuous corrosion-layer structure. Sample C (leading-edge severe exposure) displays disrupted corrosion layers and locally collapsed porous oxide structures indicative of advanced degradation.

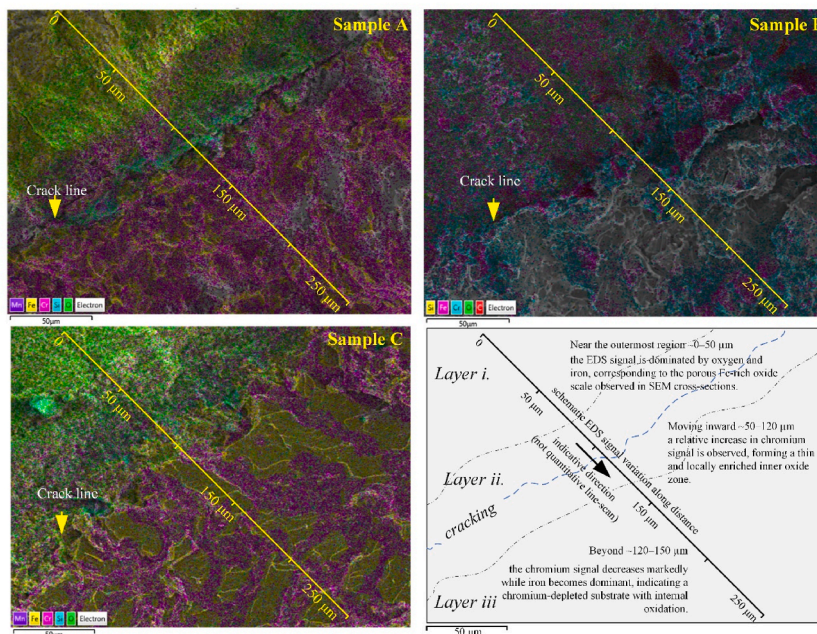
Beneath the adhesion layer, a multilayer corrosion scale is present, consisting of a porous outer oxide and a comparatively denser inner oxide layer. The structural distinction between these layers and their compositional contrast are clearly visible in the BSE images shown in Fig. 7.

Fig. 7. Cross-sectional SEM images and corresponding EDS elemental maps illustrating the multilayer corrosion architecture of the GX130CrSi29 grate bars, consisting of alkali-rich surface deposits, a porous Fe-rich outer oxide, a degraded Cr-enriched inner oxide, and a Cr-depleted substrate.

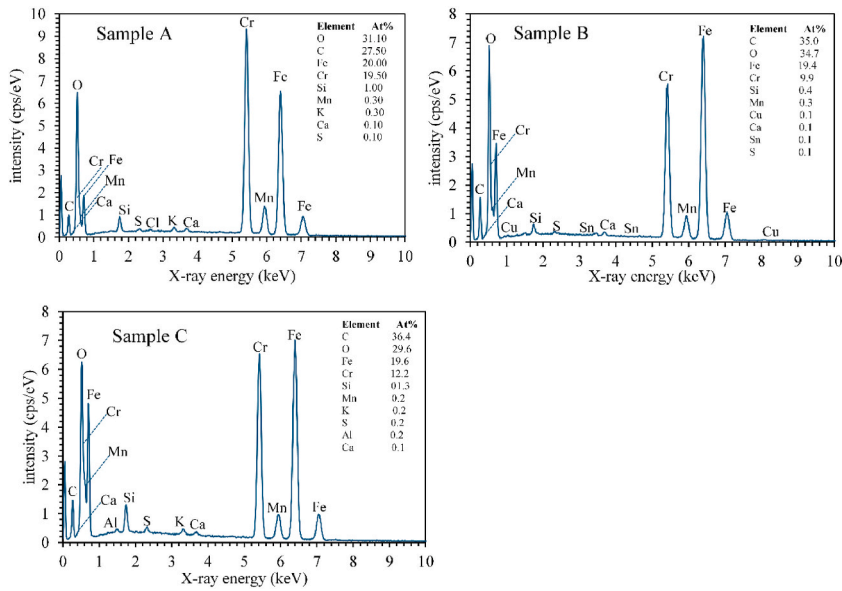
Fig. 8. EDS line-scan profiles obtained across the corrosion layers of Samples A–C, showing elemental gradients from alkali-rich surface deposits through the Fe-rich outer oxide and degraded Cr-enriched inner oxide toward the Cr-depleted substrate.

Within the corrosion scale, the outer oxide layer is dominated by Fe with only limited chromium contribution. Moving toward the oxide–metal interface, a relative increase in chromium signal intensity is observed within an intermediate oxide region corresponding to a degraded Cr-enriched inner oxide. However, chromium concentrations remain substantially lower than the nominal alloy composition of GX130CrSi29, suggesting progressive chromium depletion during service exposure of the grate bars.

Closer to the metal substrate, oxygen penetration is observed in combination with chromium depletion and trace alkali species. These compositional gradients are consistent with inward oxygen diffusion and interaction between corrosion products and biomass-derived ash components. The elemental distributions therefore provide chemical context supporting the multilayer corrosion architecture observed in the SEM images.

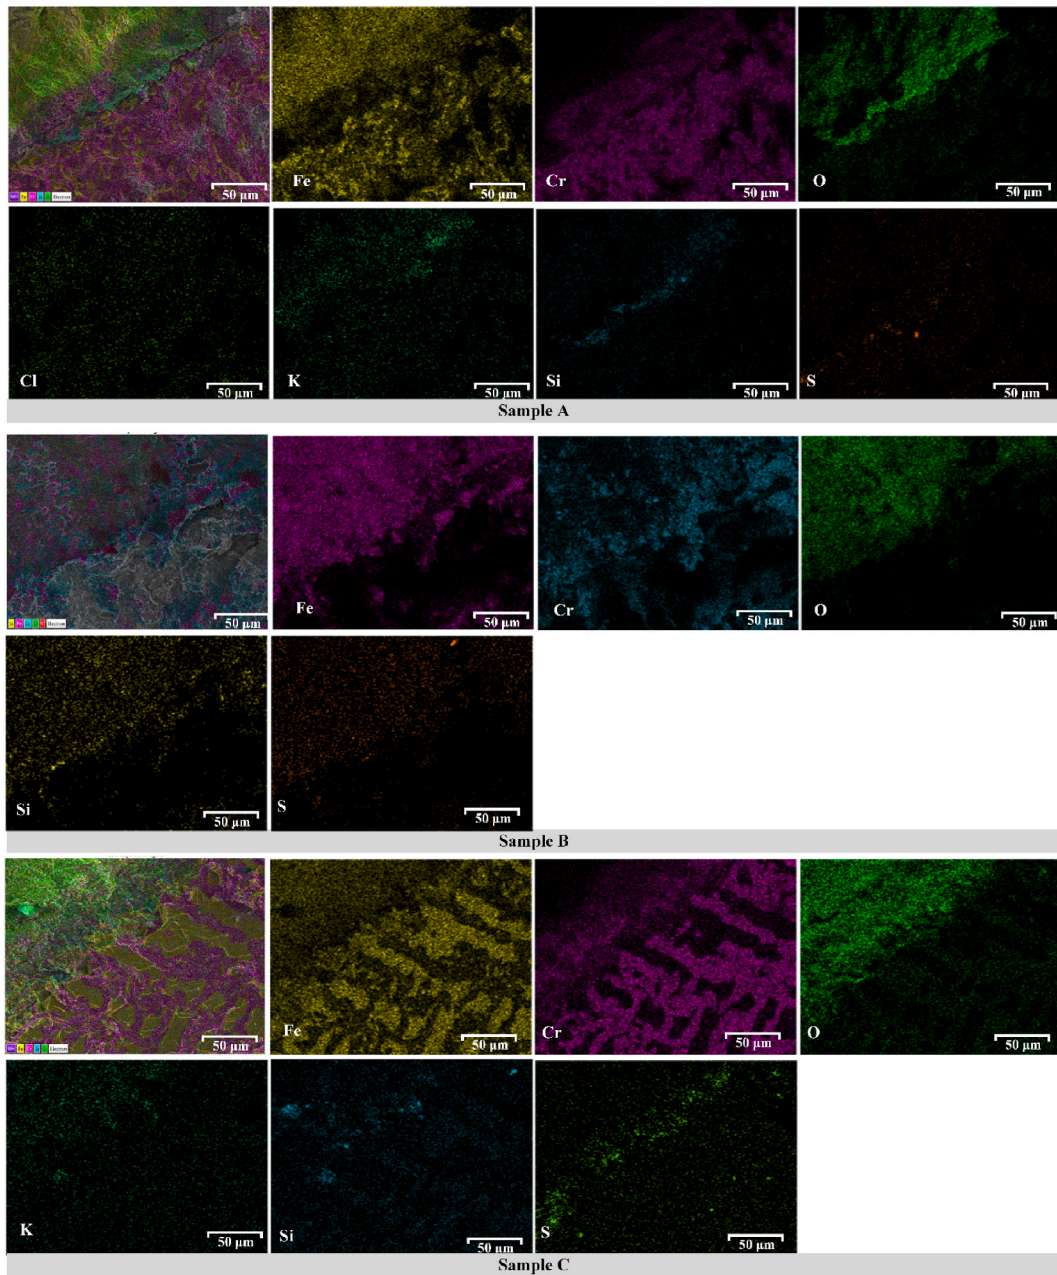
Fig. 9. EDS elemental maps of corrosion layers in Samples A–C illustrating the spatial distributions of Fe, Cr, O, K, Cl, Si, and Ca. The maps highlight alkali–silicate deposits, chromium depletion near the oxide–metal interface, and oxygen penetration into the substrate.

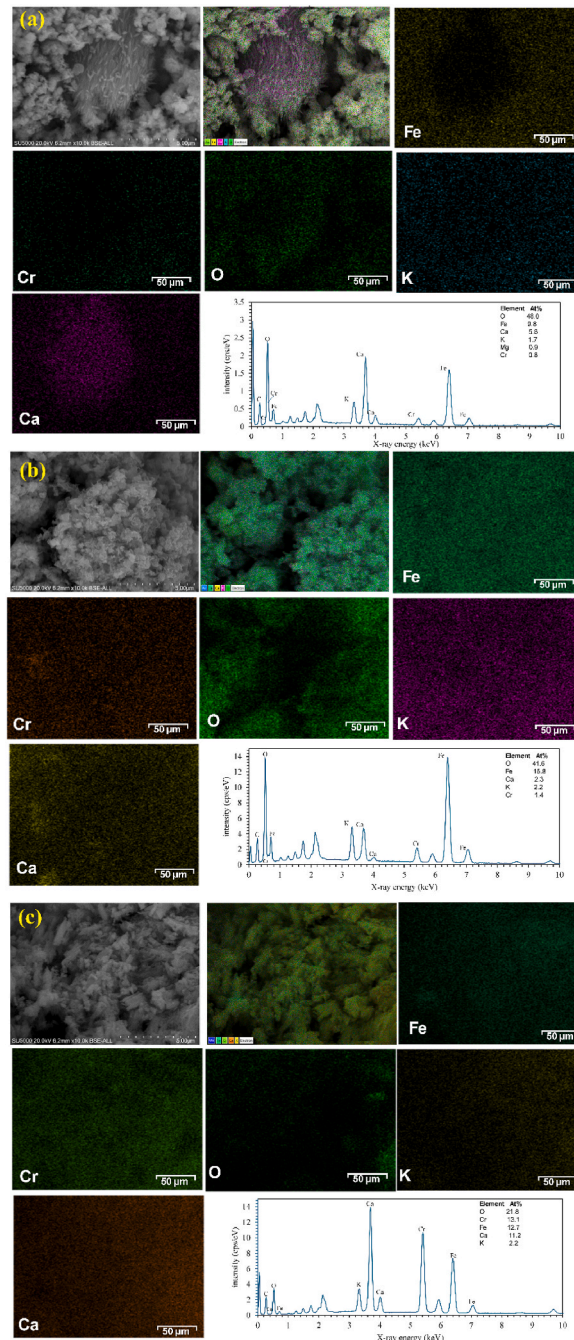
High-magnification SEM imaging combined with localized EDS analysis (Fig. 10) reveals pronounced chemical and morphological heterogeneity within the adhesion layer and upper corrosion scale.

Collectively, the SEM and EDS observations indicate that the adhesion layer and corrosion scale are chemically and morphologically heterogeneous, consisting of both oxidation-derived iron-rich oxides and alkali-rich deposit phases. Such heterogeneity reflects spatial and temporal variations in temperature, ash chemistry, and local oxygen potential within the biomass combustion environment.

Fig. 10. High-magnification SEM images with corresponding EDS elemental maps showing representative corrosion textures within the adhesion layer and corrosion scale: (a) Fe-rich oxide regions containing minor alkali species, (b) porous Fe-rich oxide scale with dispersed alkali elements, and (c) alkali- and Ca-enriched glassy corrosion products.
