Failure analysis and degradation mechanisms of GX130CrSi29 grate bars in a biomass-fired furnace: An industrial case study

Premature degradation of grate bars is a persistent operational challenge in biomass-fired furnaces, particularly when alkali-rich fuels are used, leading to increased maintenance and unplanned outages. Although biomass combustion and ash chemistry have been widely investigated, detailed failure analyses based on service-exposed grate components from operating power plants remain relatively limited. This study investigates the degradation behavior of GX130CrSi29 grate bars retrieved from a 9.9 MW rubberwood-fired reciprocating grate furnace. Failed components

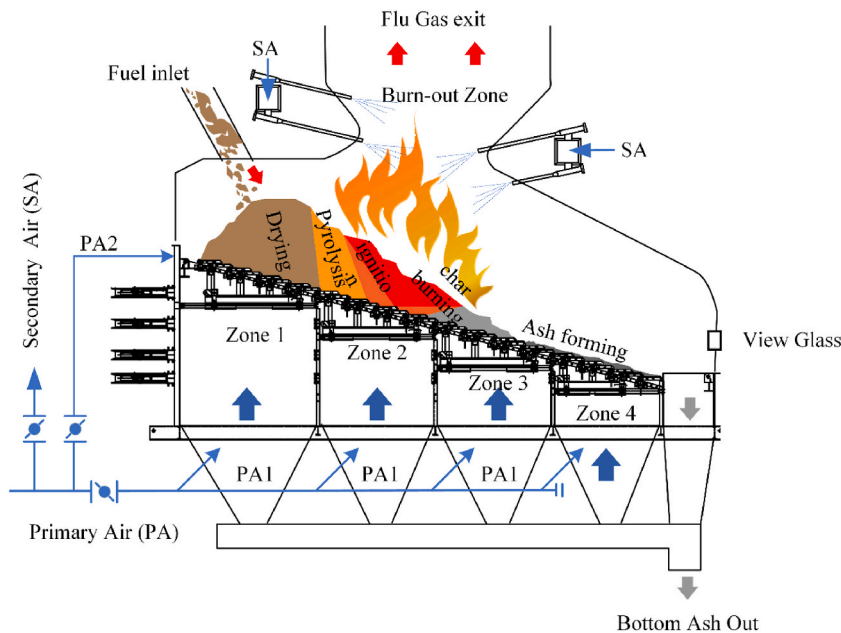
Fig. 1. Schematic diagram and representative image of the biomass-fired reciprocating grate furnace, illustrating the main combustion zones and the locations from which failed grate bars were retrieved.

The failed grate bars analyzed in this study were extracted from the high-temperature combustion zone, which represents the most severe exposure region within the furnace (Fig. 1). Grate components in this region are exposed to intense flame radiation, hot flue gases, and localized air flow from primary-air nozzles, together with deposition of alkali-rich ash particles and vapors. Typical grate-surface temperatures in this zone are reported to range from approximately 800 to 1100 °C in industrial biomass grate furnaces operating under comparable conditions [2,3,5–8]. At such temperatures, ash softening, alkali–chloride volatilization, and the formation of low-melting alkali–silicate compounds are promoted, thereby enhancing thermochemical interactions between deposits and metallic grate materials [17–21].

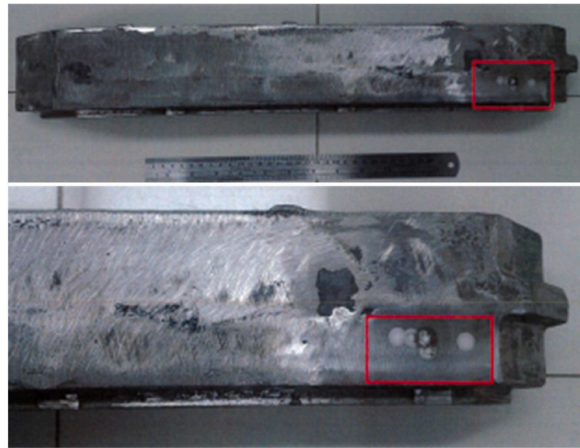
Prior to microstructural and chemical characterization of the failed components, the alloy composition of unused grate bars from the same production batch was verified by optical emission spectrometry (OES), as shown in Fig. 2. The measured elemental concentrations, summarized in Table 3, confirm that the grate bars conform to the DIN GX130CrSi29 specification. This verification was performed solely to ensure material compliance and to exclude compositional deviation as a contributing factor to the observed degradation.

Fig. 2. Photograph of a representative grate bar specimen used for optical emission spectrometry (OES) to verify the bulk chemical composition prior to microstructural analysis.

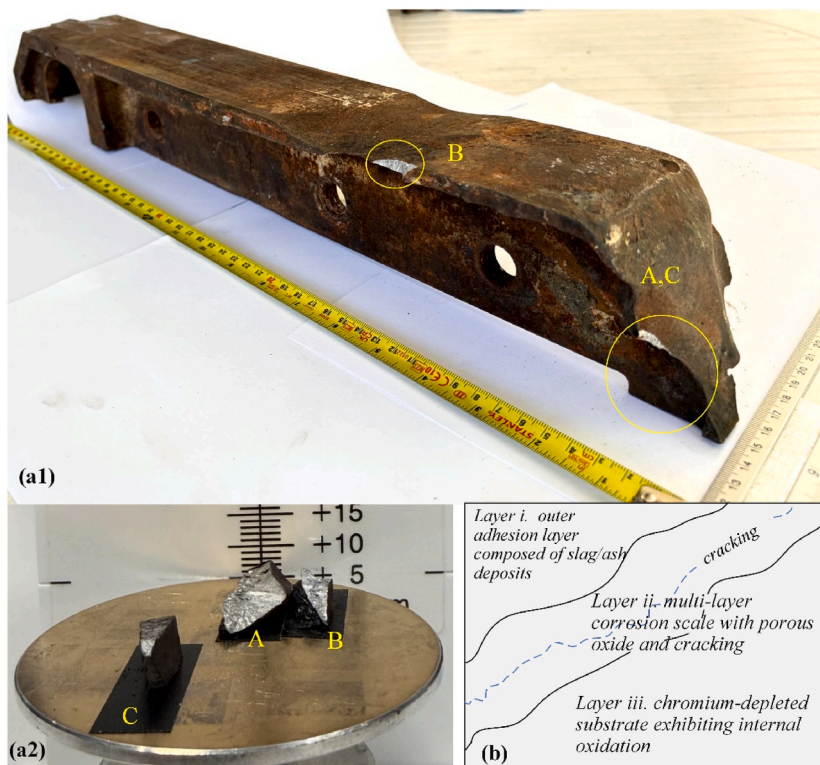
For Samples A and B, which had already fractured during service, gentle mechanical separation was used to expose cross-sections approximately perpendicular to the primary degradation direction. This approach minimized additional thermal and mechanical damage and helped preserve delicate multilayer corrosion features developed during operation, including the outer ash/slag adhesion layer, porous iron-rich oxide scales, chromium-enriched inner oxide regions, chromium-depleted metal zones, and areas of internal oxidation. The exposed fragments were subsequently mounted in epoxy resin to provide mechanical support during subsequent metallographic preparation.

Fig. 4. (a) Preparation of failed grate-bar fragments for cross-sectional analysis: Sample A – leading-edge fragment (severe degradation), Sample B – mid-grate fragment (moderate degradation), and Sample C – leading-edge fragment with severe damage prepared by controlled cutting. (b) Schematic cross-sectional orientation used for SEM imaging and EDS elemental analysis.

For Sample C, a cleaner and more planar cross-section was required to facilitate SEM/EDS line-scan and elemental mapping analyses. The specimen was therefore sectioned using a low-speed diamond cutting wheel under continuous coolant flow in order to minimize heat generation, mechanical deformation, and potential secondary oxidation. After sectioning, the specimen was mounted in epoxy and subjected to standard metallographic preparation procedures.

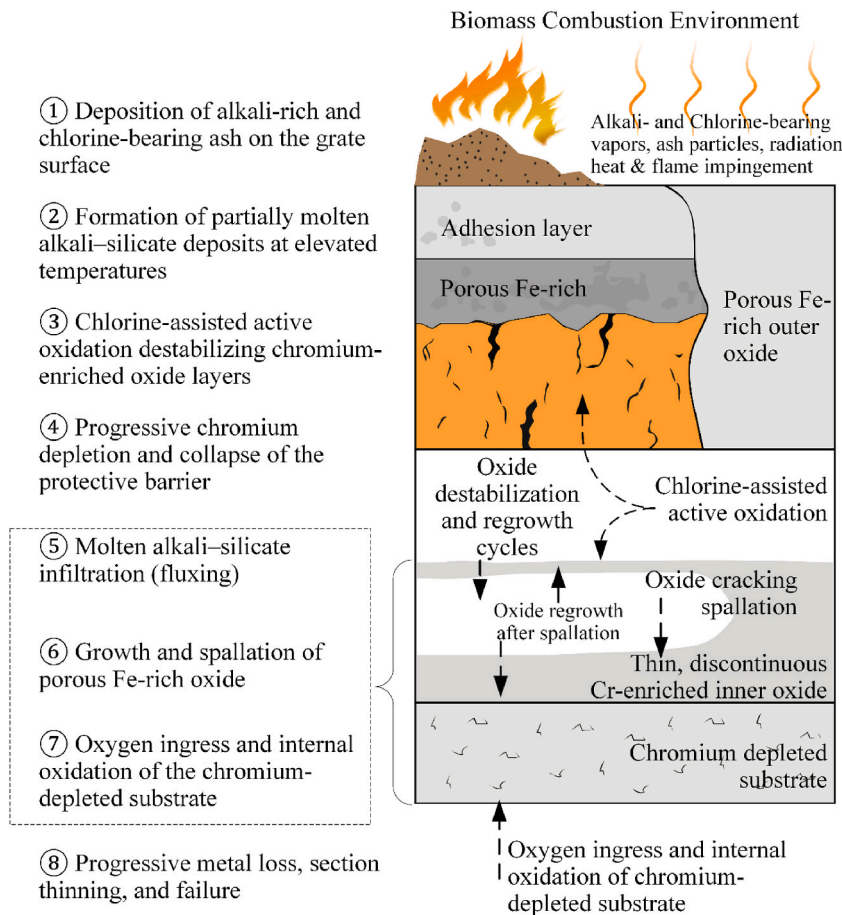
Once the chromium-based protective barrier becomes destabilized, oxidation proceeds predominantly through the formation of iron-rich oxides. SEM observations consistently reveal a thick and porous iron-rich outer oxide scale characterized by extensive cracking and void networks, particularly in the leading-edge samples (Samples A and C). These features indicate repeated oxide growth, cracking, and local detachment during service exposure. Although crystallographic phase identification was not performed in this study, the observed morphology and scale characteristics are consistent with iron-oxide-dominated corrosion layers reported in alkali- and chloride-affected high-temperature environments [17,18,20].

In parallel with oxidation processes, alkali-rich biomass ash contributes to accelerated degradation. SEM/EDS mapping reveals strong enrichment of potassium, silicon, and calcium within the adhesion layers together with evidence of penetration into the corrosion scale along pores and cracks. The glassy and partially fused morphology of these deposits, particularly in the leading-edge samples, suggests melting and resolidification during service exposure. Molten or semi-molten alkali–silicate phases can enhance degradation by dissolving protective oxides, increasing ionic transport through the scale, and weakening oxide adherence, thereby facilitating spallation and renewed oxidation [21]. In this context, alkali–silicate fluxing acts primarily as an accelerating process that intensifies corrosion once active oxidation has disrupted the protective oxide barrier.

Fig. 11. Proposed integrated degradation sequence for GX130CrSi29 grate bars under rubberwood-fired biomass combustion, illustrating ash deposition, chlorine-assisted active oxidation, formation of Fe-rich oxide scales, alkali–silicate fluxing, internal oxidation, and progressive section loss.

Based on the degradation features identified in Sections 3.1–3.4, the failure of GX130CrSi29 grate bars under rubberwood-fired biomass combustion can be interpreted as progressing through an integrated sequence of thermochemical processes. The proposed sequence is schematically illustrated in Fig. 11.

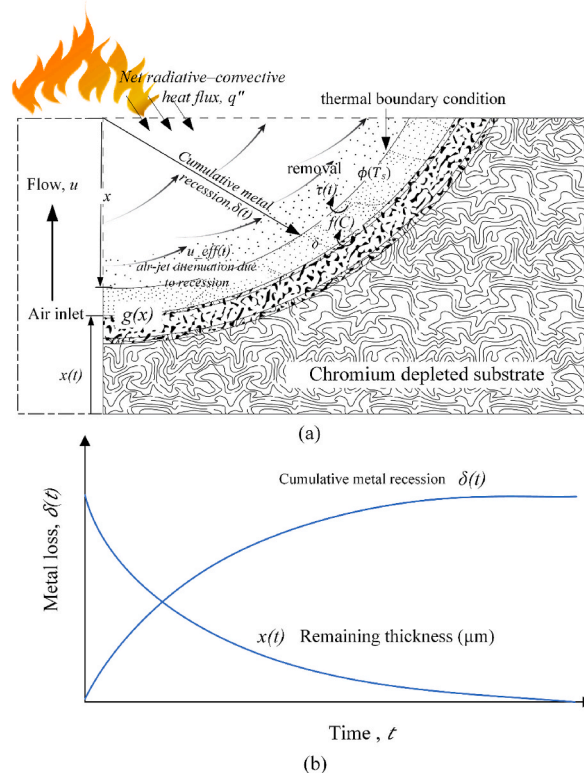
The coupled thermochemical corrosion and flow-assisted removal framework is schematically illustrated in Fig. 12(a), which summarizes the concurrent roles of thermal loading, chemical weakening of surface layers, gas-flow interaction, and progressive metal recession. The inset in Fig. 12(b) illustrates the conceptual evolution of surface-layer thickness $x(t)$ and cumulative metal loss $\delta(t)$, which may exhibit non-linear temporal behavior due to the interaction between corrosion growth and intermittent layer removal.

Fig. 12. (a) Conceptual schematic of the coupled thermochemical corrosion and flow-assisted removal framework describing grate degradation under biomass-fired conditions. (b) Conceptual evolution of surface-layer thickness $x(t)$ and cumulative metal loss $\delta(t)$, illustrating non-linear degradation associated with repeated cycles of corrosion-layer growth and removal.

where k_m represents an effective metal-loss coefficient. This formulation conceptually yields smooth degradation trajectories and conceptually reproduces the non-linear metal-loss behavior illustrated in Fig. 12(b).
